# Access Compliance Report Public Rights-of-Way (Curb Ramps)

Main Street: FAIRMONT\_WAY Cross Street: SANTA\_CLARA\_AVE Location: NE

ADA ID: RPRK220127115658 Ramp Type: Type 4 - Parallel Initial Pass/Fail: Pass Overall Compliance: No Severity Score: 5

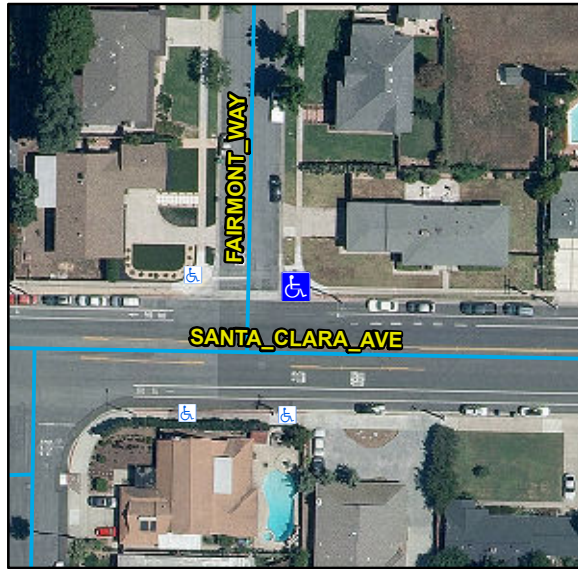
| Compliance | Description | Data | Compliance | Description | Data |
|---|---|---|---|---|---|
| No | Gutter Run Slope (%) | 6 | | Road Cross Slope (%) | 1.9 |

Remove & Replace Gutter.

R304.5.4, STD 1115
