# Access Compliance Report Public Rights-of-Way (Curb Ramps)

Main Street: YORBA\_ST Cross Street: SANTA\_CLARA\_AVE Location: NE

ADA ID: RPRK220127120105 Ramp Type: Type 4 - Parallel Initial Pass/Fail: Fail Overall Compliance: No Severity Score: 2

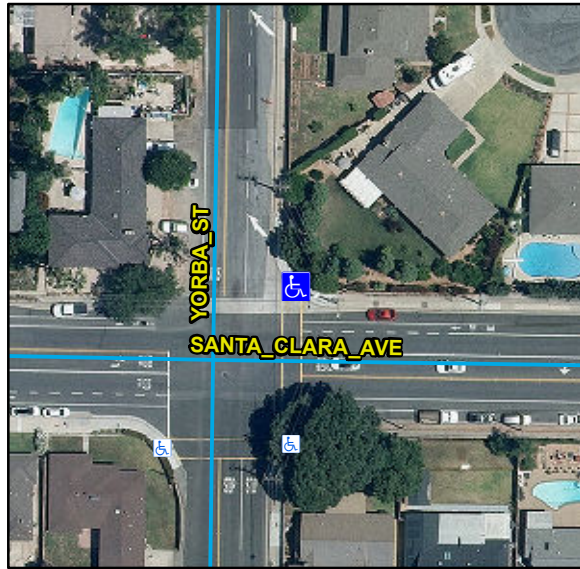
| Compliance | Description | Data | Compliance | Description | Data |
|---|---|---|---|---|---|
| Yes | Ramp Cross Slope LT (%) | 1.5 | No | Ramp Cross Slope RT (%) | 2.3 |

**Remove & Replace Curb Ramp With Two New Directional Ramps or Equivalent.**

**R304.5.3, STD 1115**
