# Access Compliance Report Public Rights-of-Way (Curb Ramps)

| Main Street: SANTA_CLARA_AVE | | Cross Street: YORBA_ST | | Location: | SE |
| ADA ID: RPRK220127120345 | Ramp Type: Type 4 - Parallel | Initial Pass/Fail: Pass | Overall Compliance: No | Severity Score: | 0 |

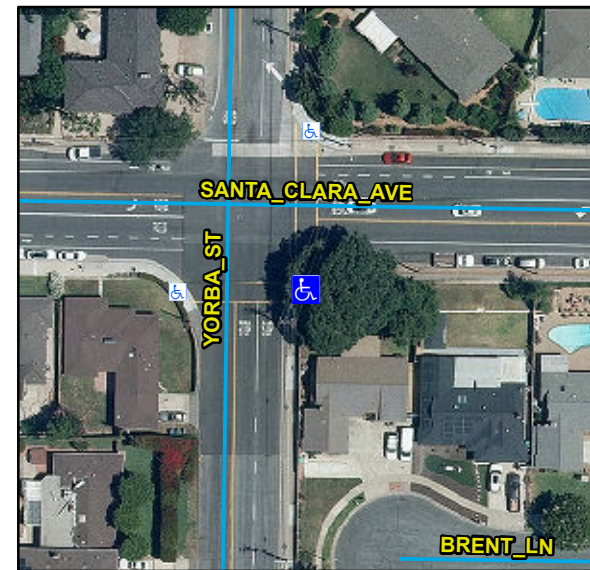
| Compliance | Description | Data | Compliance | Description | Data |
|---|---|---|---|---|---|
| Yes | Ramp Inside Crosswalk 1 | Yes | No | Ramp Inside Crosswalk 2 | No |

Possible Solutions:

Restripe Crosswalk.

R207.1, STD 1115
