# Access Compliance Report Public Rights-of-Way (Curb Ramps)

Main Street: YORBA\_ST Cross Street: SANTA\_CLARA\_AVE Location: SW

ADA ID: RPRK220127120721 Ramp Type: Type 4 - Parallel Initial Pass/Fail: Fail Overall Compliance: No Severity Score: 2

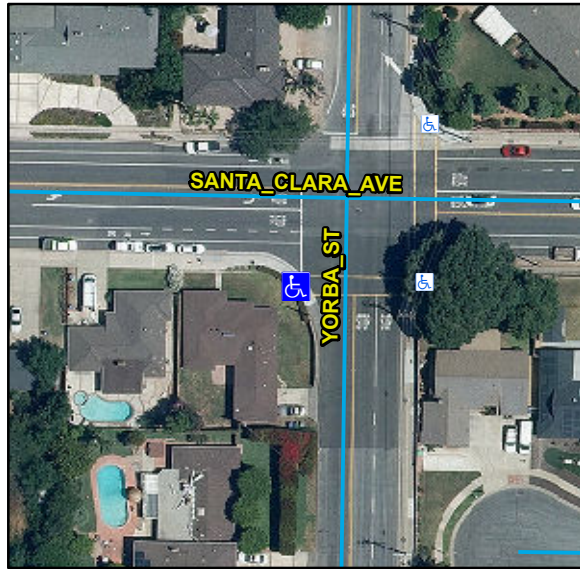
| Compliance | Description | Data | Compliance | Description | Data |
|---|---|---|---|---|---|
| Yes | Ramp Run Slope LT (%) | 1.8 | Yes | Ramp Run Slope RT (%) | 7 |
| No | Ramp Cross Slope LT (%) | 2.2 | No | Ramp Cross Slope RT (%) | 2.1 |

Remove & Replace Curb Ramp With Two New Directional Ramps or Equivalent.

R304.5.3, STD 1115
