Access Compliance Report Public Rights-of-Way (Curb Ramps)

Main Street: SANTA_CLARA_AVE **Cross Street: WHEELER_PL** **Location: SE**

ADA ID: RPRK220127121215 **Ramp Type: Type 4 - Parallel** **Initial Pass/Fail: Fail** **Overall Compliance: No** **Severity Score: 16**

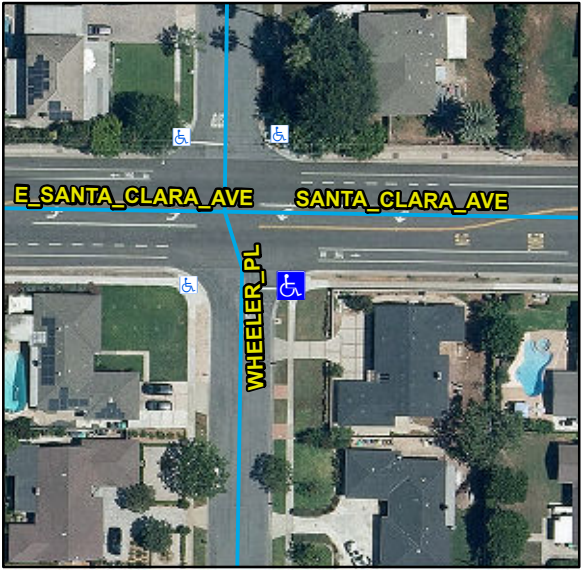
Compliance	Description	Data	Compliance	Description	Data
N/A	Ramp Length LT (in)	88	N/A	Ramp Length RT (in)	60
Yes	Ramp Width LT (in)	91	Yes	Ramp Width RT (in)	91
No	Ramp Run Slope LT (%)	9.1	Yes	Ramp Run Slope RT (%)	1.7
Yes	Ramp Cross Slope LT (%)	1.6	No	Ramp Cross Slope RT (%)	3.5
N/A	Landing Present	N/A	N/A	DWS Provided	N/A
N/A	Landing Length (in)	N/A	N/A	DWS Contrast	N/A
N/A	Landing Width (in)	N/A	N/A	DWS Length (in)	N/A
N/A	Landing Run Slope (%)	N/A	N/A	DWS Full Width	N/A
N/A	Landing Cross Slope (%)	N/A		DWS Offset Type	N/A
N/A	Landing Movement Obstructed?	N/A	N/A	DWS Offset Left (in)	N/A
	Landing Movement Type	N/A	N/A	DWS Offset Right (in)	N/A
N/A	Landing Shared	N/A			
N/A	Clear Space	Yes			
N/A	Clear Space To Crosswalk (in)	N/A			
N/A	Marked Crosswalk 1	No	N/A	Marked Crosswalk 2	No
	Crossing 1 Direction	N		Crossing 2 Direction	W
N/A	Marked Crosswalk 1 Width (in)	N/A		Marked Crosswalk 2 Width (in)	N/A

Possible Solutions:
Remove & Replace Curb Ramp With Two New Directional Ramps or Equivalent.

OC Std/PROW:
 R304.3.2, R304.5.3, STD 1115

Total Cost: \$ 4000
