# Access Compliance Report Public Rights-of-Way (Curb Ramps)

Main Street: ALLEGHENY\_DR Cross Street: LAURINDA\_WAY Location: SE

ADA ID: RPRK220127121615 Ramp Type: Type 4 - Parallel Initial Pass/Fail: Fail Overall Compliance: No Severity Score: 2

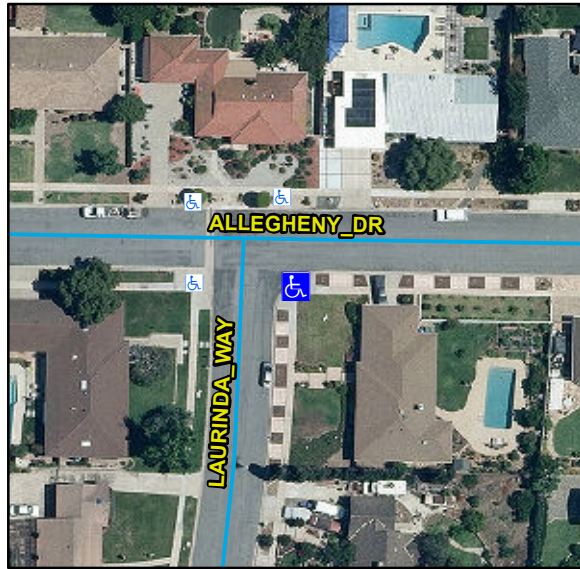
| Compliance | Description | Data | Compliance | Description | Data |
|---|---|---|---|---|---|
| Yes | Ramp Cross Slope LT (%) | 0.8 | No | Ramp Cross Slope RT (%) | 3 |
| N/A | Gutter Ponding | N/A | No | Curb Slope | 8.7 |

**Remove & Replace Curb Ramp With Two New Directional Ramps or Equivalent.**

**R304.2.2, R204.3, R304.5.3, STD 1115**

Total Cost: \$ 4000
