# Access Compliance Report Public Rights-of-Way (Curb Ramps)

| Main Street: LAURINDA_WAY | | Cross Street: ALLEGHENY_DR | | Location: | SW |
| ADA ID: RPRK220127121928 | Ramp Type: Type 4 - Parallel | Initial Pass/Fail: Fail | Overall Compliance: No | Severity Score: | 15 |

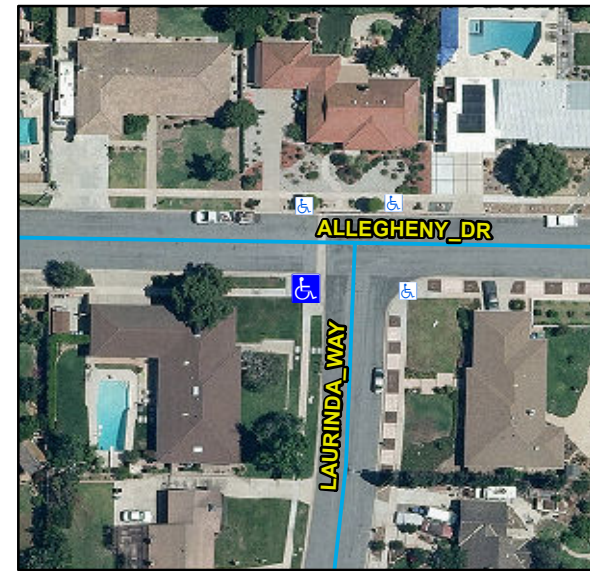
| Compliance | Description | Data | Compliance | Description | Data |
|---|---|---|---|---|---|
| Yes | Ramp Run Slope LT (%) | 4 | No | Ramp Run Slope RT (%) | 9 |

**Remove & Replace Curb Ramp With Two New Directional Ramps or Equivalent.**

**R204.3, R304.3.2, STD 1115**

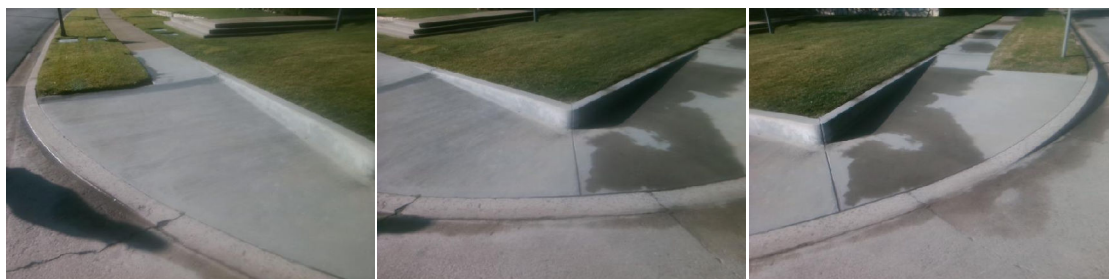
| Compliance | Description | Data | Compliance | Description | Data |
|---|---|---|---|---|---|
| N/A | Ramp Length LT (in) | 156 | N/A | Ramp Length RT (in) | 141 |
| Yes | Ramp Width LT (in) | 103 | Yes | Ramp Width RT (in) | 100 |
| Yes | Ramp Cross Slope LT (%) | 1.5 | Yes | Ramp Cross Slope RT (%) | 1 |
