# Access Compliance Report Public Rights-of-Way (Curb Ramps)

Main Street: CARLSBAD\_DR Cross Street: PROSPECT\_AVE Location: SE

ADA ID: RPRK220127122634 Ramp Type: Type 4 - Parallel Initial Pass/Fail: Pass Overall Compliance: No Severity Score: 0

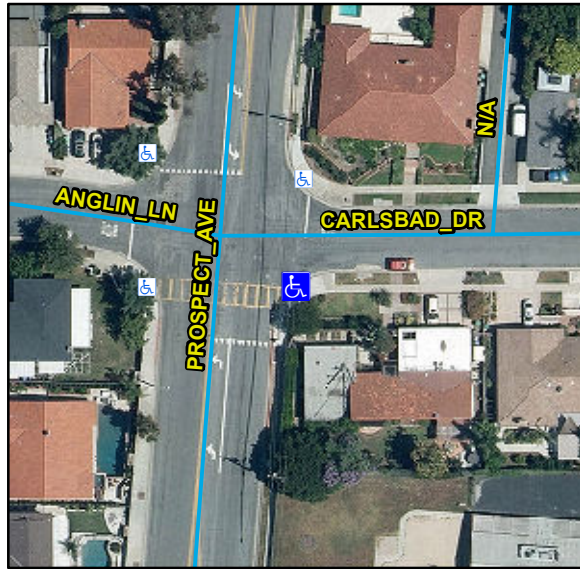
| Compliance | Description | Data | Compliance | Description | Data |
|---|---|---|---|---|---|
| N/A | Landing Present | Yes | Yes | DWS Provided | Yes |
| N/A | Landing Length (in) | 108 | Yes | DWS Contrast | Yes |
| Yes | Landing Width (in) | 48 | Yes | DWS Length (in) | 36 |
| No | Landing Run Slope (%) | 2.3 | Yes | DWS Full Width | Yes |

Remove & Replace Landing. Restripe Crosswalk.
