# Access Compliance Report Public Rights-of-Way (Curb Ramps)

Main Street: PROSPECT\_AVE Cross Street: ANGLIN\_LN Location: SW

ADA ID: RPRK220127123105 Ramp Type: Type 4 - Parallel Initial Pass/Fail: Pass Overall Compliance: No Severity Score: 5

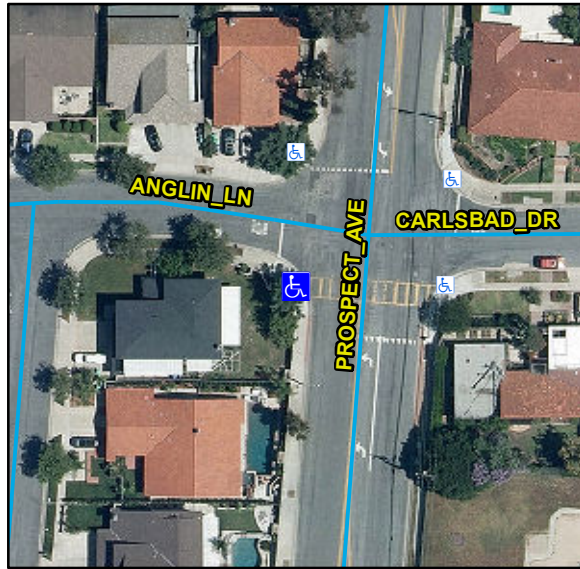
| Compliance | Description | Data | Compliance | Description | Data |
|---|---|---|---|---|---|
| No | Gutter Run Slope (%) | 5.1 | | Road Cross Slope (%) | 3.6 |

Remove & Replace Gutter.

R304.5.4, STD 1115

Total Cost: \$ 252
