# Access Compliance Report Public Rights-of-Way (Curb Ramps)

Main Street: PROSPECT\_AVE Cross Street: CARLSBAD\_DR Location: NE

ADA ID: RPRK220127123802 Ramp Type: Type 1 - Perpendicular Diagonal Initial Pass/Fail: Pass Overall Compliance: No Severity Score: 15

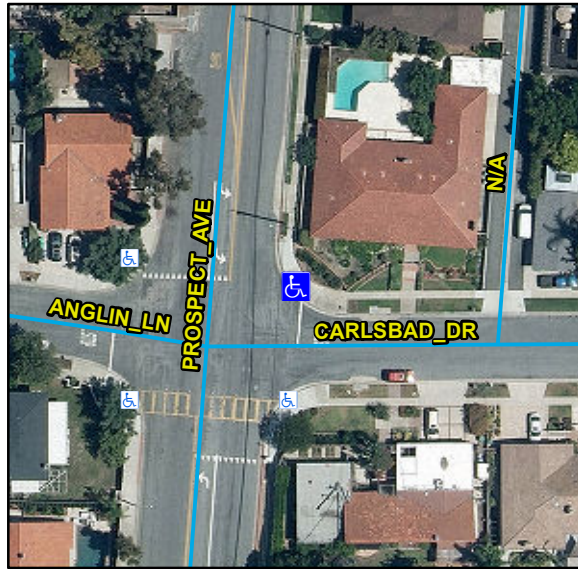
| Compliance | Description | Data | Compliance | Description | Data |
|---|---|---|---|---|---|
| Yes | Landing Cross Slope (%) | 0.7 | No | DWS Provided | No |
| No | Gutter Lip Height (in) | 0.25 | | Road Run Slope (%) | 3.4 |
| No | Gutter Run Slope (%) | 8.6 | | Road Cross Slope (%) | 6.1 |

Remove & Replace Curb Ramp With Two New Directional Ramps or Equivalent. Remove & Replace Gutter.
