Access Compliance Report Public Rights-of-Way (Curb Ramps)

Main Street: PROSPECT_ST		Cross Street: E_ROMELLE_AVE		Location:	NE
ADA ID: RPRK220127124539	Ramp Type: Type 4 - Parallel	Initial Pass/Fail: Pass	Overall Compliance: Yes	Severity Score:	2

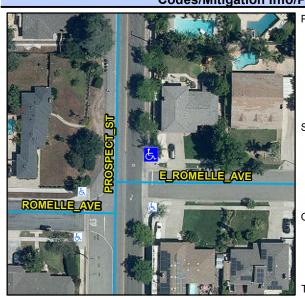
Field Measurements/Component Compliance							
	Compliance Description		Data	Com	Compliance Description		
	N/A	Ramp Length LT (in)	76	N/A	Ramp Length RT (in)	78	
	Yes	Ramp Width LT (in)	84	Yes	Ramp Width RT (in)	84	
	Yes	Ramp Run Slope LT (%)	4.9	Yes	Ramp Run Slope RT (%)	4.7	
	Yes	Ramp Cross Slope LT (%)	2	Yes	Ramp Cross Slope RT (%)	1	
	N/A	Landing Present	Yes	Yes	DWS Provided	Yes	
	N/A	Landing Length (in)	82	Yes	DWS Contrast	Yes	
	Yes	Landing Width (in)	48	Yes	DWS Length (in)	36	
	Yes	Landing Run Slope (%)	1.9	Yes	DWS Full Width	Yes	
	Yes	Landing Cross Slope (%)	1.6		DWS Offset Type	Single	
	N/A	Landing Movement Obstructed?	No	Yes	DWS Offset Left (in)	0	
		Landing Movement Type	Curb	Yes	DWS Offset Right (in)	N/A	
	N/A	Landing Shared	No				
	N/A	Clear Space	Yes				
	N/A	Clear Space To Crosswalk (in)	48				
\$ 0	N/A	Marked Crosswalk 1	No	N/A	Marked Crosswalk 2	No	
		Crossing 1 Direction	W		Crossing 2 Direction	S

SPECT_ST		Marked Crosswalk 1 Width (in)	N/A		Marked Crosswalk 2 Width (in)	N/A	
NoControl	N/A	Ramp Inside Crosswalk 1	N/A	N/A	Ramp Inside Crosswalk 2	N/A	
ELLE_AVE		Crossing 1 Slope (%)	3.1		Crossing 2 Slope (%)	3	
StopSign		Crossing 1 Cross Slope (%)	1.9		Crossing 2 Cross Slope (%)	2.3	
	Yes	Gutter Ponding	No	Yes	Curb Slope	7.4	
	Yes	Gutter Lip Height (in)	0		Road Run Slope (%)	0.6	
5 .	Yes	Gutter Run Slope (%)	4.8		Road Cross Slope (%)	5.8	
Data	Yes	Gutter Cross Slope (%)	0.6	Yes	Perpendicular Joint Present	Yes	
No	Yes	Overall Surface Condition Acceptable					
		Cross Gutter Present?	Yes		Spandrel Present?	Yes	
N/A		Replace Cross Gutter?	No		Replace Spandrel?	No

Possible Solutions: N/A
