# Access Compliance Report Public Rights-of-Way (Curb Ramps)

Main Street: DODGE\_AVE Cross Street: ETON\_PL Location: SE

ADA ID: RPRK220127130854 Ramp Type: Type 4 - Parallel Initial Pass/Fail: Pass Overall Compliance: No Severity Score: 0

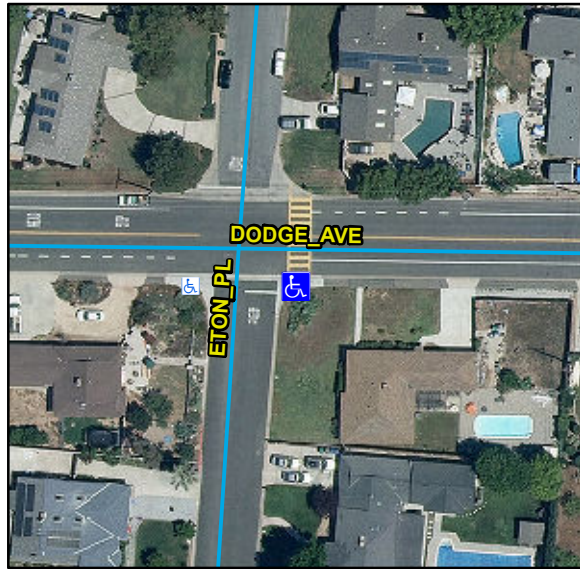
| Compliance | Description | Data | Compliance | Description | Data |
|---|---|---|---|---|---|
| N/A | Landing Length (in) | 54 | Yes | DWS Contrast | Yes |
| N/A | Landing Movement Obstructed? | Yes | Yes | DWS Offset Left (in) | 0 |
| | Landing Movement Type | Curb | Yes | DWS Offset Right (in) | N/A |

Possible Solutions:

Remove & Replace Landing.

R304.2.1, STD 1115

Total Cost: \$ 531
