# Access Compliance Report Public Rights-of-Way (Curb Ramps)

Main Street: GIMBERT\_LN Cross Street: SILVER\_MAPLE\_WAY Location: SW

ADA ID: RPRK220127133623 Ramp Type: Type 1 - Perpendicular Diagonal Initial Pass/Fail: Pass Overall Compliance: No Severity Score: 0

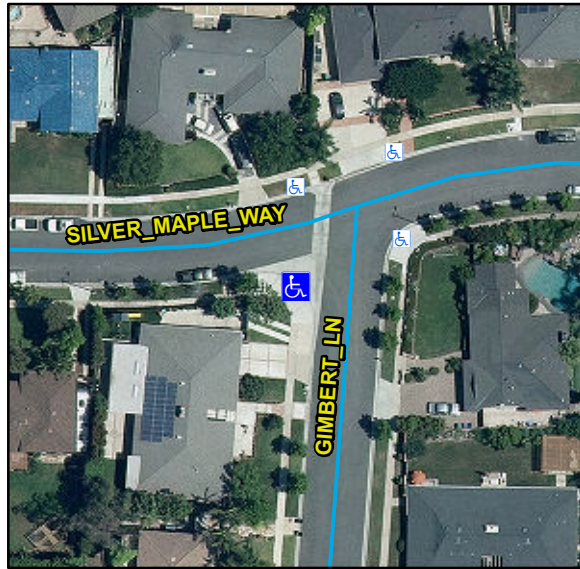
| Compliance | Description | Data | Compliance | Description | Data |
|---|---|---|---|---|---|
| No | Landing Run Slope (%) | 2.3 | N/A | Flare Traversable RT | No |
| No | Gutter Cross Slope (%) | 2.6 | | | |

Remove & Replace Landing. Remove & Replace Gutter.
