# Access Compliance Report Public Rights-of-Way (Curb Ramps)

Main Street: SILVER\_MAPLE\_WAY Cross Street: GIMBERT\_LN Location: SE

ADA ID: RPRK220127133924 Ramp Type: Type 1 - Perpendicular Diagonal Initial Pass/Fail: Pass Overall Compliance: No Severity Score: 6

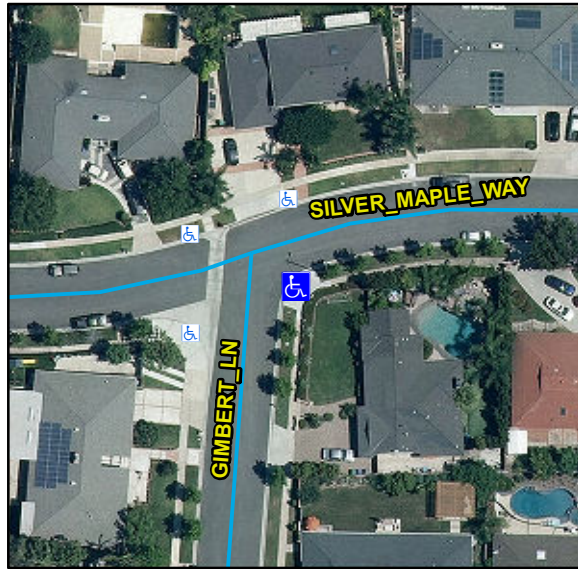
R304.2.1, R304.5.4, STD 1115

| Compliance | Description | Data | Compliance | Description | Data |
|---|---|---|---|---|---|
| No | Gutter Run Slope (%) | 6.5 | | Road Cross Slope (%) | 3.5 |

Remove & Replace Landing. Remove & Replace Gutter.
