# Access Compliance Report Public Rights-of-Way (Curb Ramps)

Main Street: GIMBERT\_LN Cross Street: GREEN\_WILLOW\_CT Location: NE

ADA ID: RPRK220127134215 Ramp Type: Type 1 - Perpendicular Diagonal Initial Pass/Fail: Pass Overall Compliance: No Severity Score: 2

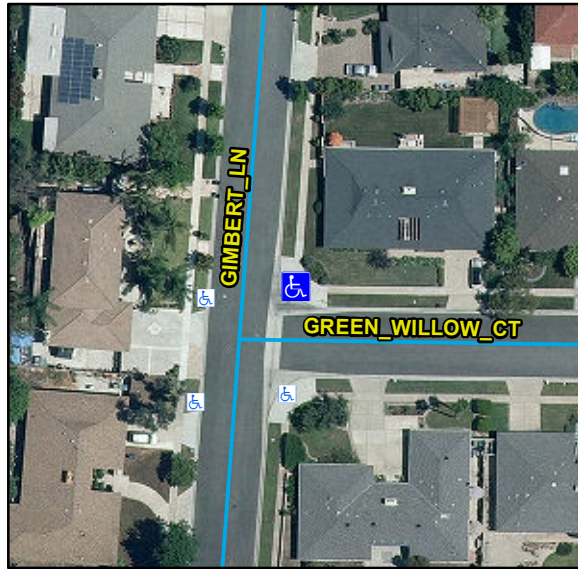
| Compliance | Description | Data | Compliance | Description | Data |
|---|---|---|---|---|---|
| N/A | Landing Movement Obstructed? | Yes | Yes | DWS Contrast | Yes |
| | Landing Movement Type | Curb | Yes | DWS Length (in) | 36 |

Possible Solutions:

Remove & Replace Landing.

R304.2.1, STD 1115
