# Access Compliance Report Public Rights-of-Way (Curb Ramps)

| Main Street: GREEN_WILLOW_CT | | Cross Street: GIMBERT_LN | | Location: | SE |
| ADA ID: RPRK220127134605 | Ramp Type:Type 1 - Perpendicular Diagonal Initial Pass/Fail: Pass | | Overall Compliance: No | Severity Score: | 0 |

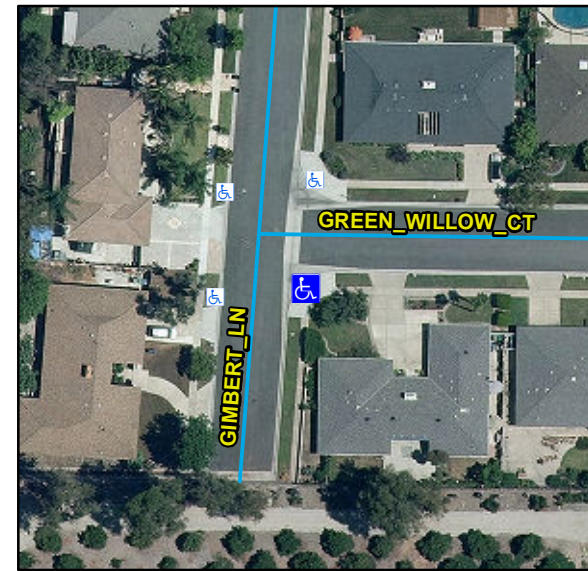
| Compliance | Description | Data | Compliance | Description | Data |
|---|---|---|---|---|---|
| No | Landing Run Slope (%) | 2.5 | N/A | Flare Traversable RT | No |
| Yes | Gutter Ponding | No | No | Curb Slope | 8.2 |

**Remove & Replace Curb Ramp With Two New Directional Ramps or Equivalent.**

**R304.2.2, R304.2.1, R304.2.2-Perp, R304.3.2-Para, STD 1115**
