# Access Compliance Report Public Rights-of-Way (Curb Ramps)

Main Street: HEWES\_AVE Cross Street: FOOTHILL\_BLVD Location: NE

ADA ID: RPRK220127135503 Ramp Type: Type 1 - Perpendicular Diagonal Initial Pass/Fail: Pass Overall Compliance: No Severity Score: 4

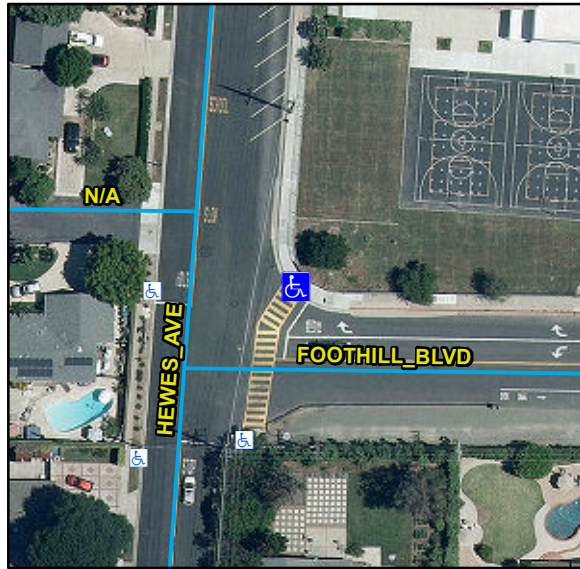
| Compliance | Description | Data | Compliance | Description | Data |
|---|---|---|---|---|---|
| N/A | Landing Movement Obstructed? | Yes | Yes | DWS Contrast | Yes |
| | Landing Movement Type | Curb | Yes | DWS Length (in) | 36 |

Remove & Replace Landing.

R304.2.1, STD 1115

Total Cost: \$ 531
