# Access Compliance Report Public Rights-of-Way (Curb Ramps)

Main Street: HEWES\_AVE Cross Street: SPAULDING\_AVE Location: SE

ADA ID: RPRK220127135827 Ramp Type: Type 4 - Parallel Initial Pass/Fail: Fail Overall Compliance: No Severity Score: 2

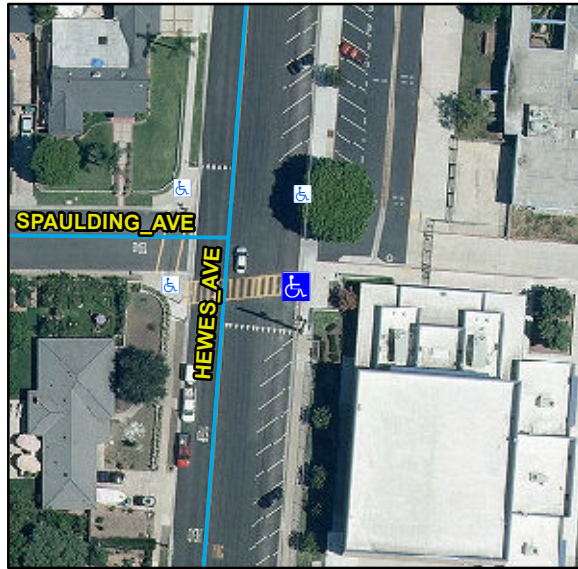
| Compliance | Description | Data | Compliance | Description | Data |
|---|---|---|---|---|---|
| No | Ramp Cross Slope LT (%) | 3.1 | Yes | Ramp Cross Slope RT (%) | 0.7 |

**Remove & Replace Entire Ramp.**

**R304.5.3, STD 1115**
