# Access Compliance Report Public Rights-of-Way (Curb Ramps)

Main Street: HEWES\_AVE Cross Street: SPAULDING\_AVE Location: SW

ADA ID: RPRK220127140132 Ramp Type: Type 4 - Parallel Initial Pass/Fail: Fail Overall Compliance: No Severity Score: 16

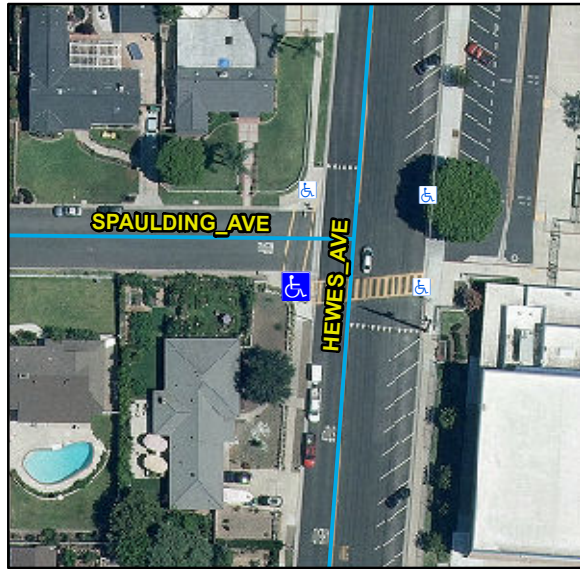
| Compliance | Description | Data | Compliance | Description | Data |
|---|---|---|---|---|---|
| Yes | Ramp Run Slope LT (%) | 3.96 | No | Ramp Run Slope RT (%) | 8.5 |
| No | Ramp Cross Slope LT (%) | 2.5 | No | Ramp Cross Slope RT (%) | 3.4 |

**Remove & Replace Curb Ramp With Two New Directional Ramps or Equivalent.**

**R304.5.3, R304.3.2, STD 1115**
