# Access Compliance Report Public Rights-of-Way (Curb Ramps)

Main Street: HEWES\_AVE Cross Street: VALE\_AVE Location: SW

ADA ID: RPRK220127140405 Ramp Type: Type 4 - Parallel Initial Pass/Fail: Pass Overall Compliance: No Severity Score: 6

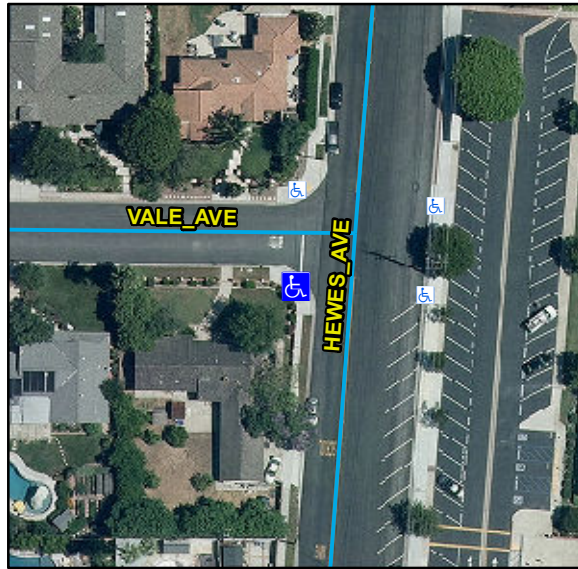
| Compliance | Description | Data | Compliance | Description | Data |
|---|---|---|---|---|---|
| No | Landing Run Slope (%) | 2.2 | Yes | DWS Full Width | Yes |
| No | Gutter Run Slope (%) | 10.8 | | Road Cross Slope (%) | 2.3 |

Remove & Replace Landing. Remove & Replace Gutter.
