Access Compliance Report Public Rights-of-Way (Curb Ramps)

Main Street: VALE_AVE **Cross Street: HEWES_AVE** **Location: NW**

ADA ID: RPRK220127140809 **Ramp Type: Type 4 - Parallel** **Initial Pass/Fail: Pass** **Overall Compliance: No** **Severity Score: 0**

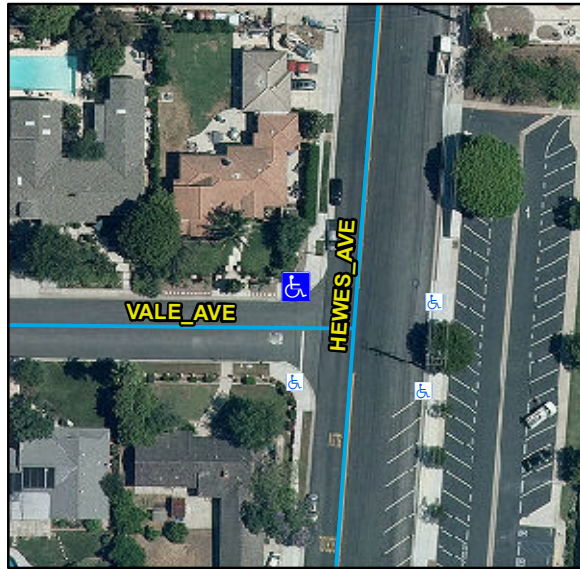
Compliance	Description	Data	Compliance	Description	Data
N/A	Ramp Length LT (in)	86	N/A	Ramp Length RT (in)	86
Yes	Ramp Width LT (in)	87	Yes	Ramp Width RT (in)	87
Yes	Ramp Run Slope LT (%)	5.8	Yes	Ramp Run Slope RT (%)	8.2
Yes	Ramp Cross Slope LT (%)	0.6	Yes	Ramp Cross Slope RT (%)	0.6
N/A	Landing Present	Yes	Yes	DWS Provided	Yes
N/A	Landing Length (in)	87	Yes	DWS Contrast	Yes
Yes	Landing Width (in)	48	Yes	DWS Length (in)	36
No	Landing Run Slope (%)	2.1	Yes	DWS Full Width	Yes
Yes	Landing Cross Slope (%)	0.5		DWS Offset Type	Single
N/A	Landing Movement Obstructed?	No	Yes	DWS Offset Left (in)	0
	Landing Movement Type	Curb	Yes	DWS Offset Right (in)	N/A
N/A	Landing Shared	No			
N/A	Clear Space	Yes			
N/A	Clear Space To Crosswalk (in)	48			
N/A	Marked Crosswalk 1	No	N/A	Marked Crosswalk 2	No
	Crossing 1 Direction	S		Crossing 2 Direction	E
	Marked Crosswalk 1 Width (in)	N/A		Marked Crosswalk 2 Width (in)	N/A
N/A	Ramp Inside Crosswalk 1	N/A	N/A	Ramp Inside Crosswalk 2	N/A

Possible Solutions:
Remove & Replace Landing.

OC Std/PROW:
R304.2.2-Perp, R304.3.2-Para, STD 1115

Total Cost: \$ 531
