# Access Compliance Report Public Rights-of-Way (Curb Ramps)

Main Street: EARLHAM\_ST Cross Street: FAIRHAVEN\_AVE Location: NE

ADA ID: RPRK220127141327 Ramp Type: Type 4 - Parallel Initial Pass/Fail: Fail Overall Compliance: No Severity Score: 2

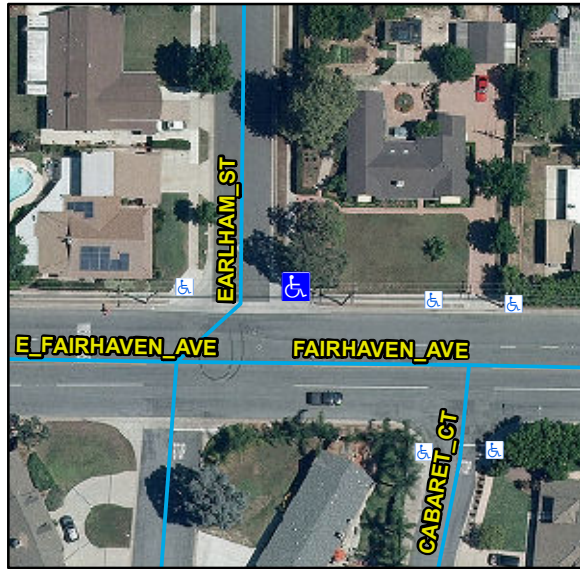
| Compliance | Description | Data | Compliance | Description | Data |
|---|---|---|---|---|---|
| No | Ramp Cross Slope LT (%) | 3.2 | No | Ramp Cross Slope RT (%) | 2.9 |

Remove & Replace Curb Ramp With Two New Directional Ramps or Equivalent.

R304.5.3, STD 1115
