Access Compliance Report Public Rights-of-Way (Curb Ramps)

Main Street: **N/A** Cross Street: **HEWES_AVE** Location: **SE**

ADA ID: **RPRK220127142104** Ramp Type: **Type 1 - Perpendicular Diagonal Initial Pass/Fail: Fail** Overall Compliance: **No** Severity Score: **2**

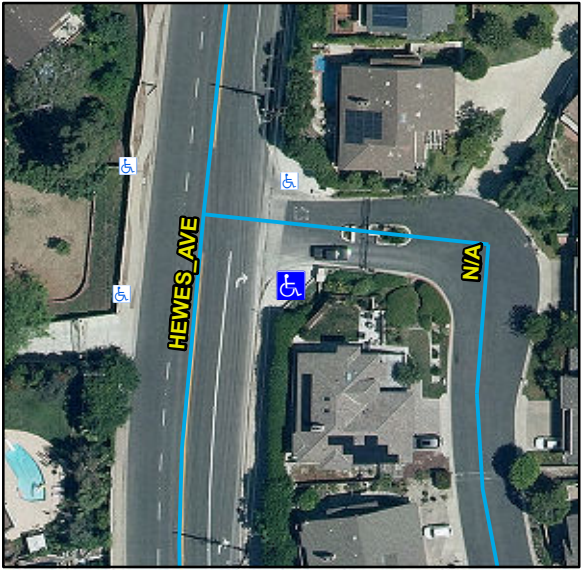
Compliance	Description	Data	Compliance	Description	Data
N/A	Ramp Length (in)	110	N/A	Flare Type LT	
Yes	Ramp Width (in)	48			N/A
Yes	Ramp Run Slope (%)	7.9	N/A	Flare Slope LT (%)	N/A
No	Ramp Cross Slope (%)	2.8	N/A	Flare Traversable LT	N/A
N/A	Landing Present	N/A	N/A	Flare Type RT	
N/A	Landing Length (in)	N/A			N/A
N/A	Landing Width (in)	N/A	N/A	Flare Slope RT (%)	N/A
N/A	Landing Run Slope (%)	N/A	N/A	Flare Traversable RT	N/A
N/A	Landing Cross Slope (%)	N/A	N/A	DWS Provided	N/A
N/A	Landing Movement Obstructed?	N/A	N/A	DWS Contrast	N/A
	Landing Movement Type	N/A	N/A	DWS Length (in)	N/A
N/A	Landing Shared	N/A	N/A	DWS Full Width	N/A
N/A	Clear Space	Yes	N/A	DWS Offset Left (in)	N/A
N/A	Clear Space To Crosswalk (in)	N/A	N/A	DWS Offset Right (in)	N/A
N/A	Marked Crosswalk 1	No	N/A	Marked Crosswalk 2	No
	Crossing 1 Direction	N		Crossing 2 Direction	W
	Marked Crosswalk 1 Width (in)	N/A		Marked Crosswalk 2 Width (in)	N/A

N/A	Ramp Inside Crosswalk 1	N/A	Yes	Ramp Inside Crosswalk 2	N/A
	Crossing 1 Slope (%)	1.9		Crossing 2 Slope (%)	6.7
	Crossing 1 Cross Slope (%)	3.6		Crossing 2 Cross Slope (%)	0.1
N/A	Gutter Ponding	N/A	No	Curb Slope	7.8
Yes	Gutter Lip Height (in)	0		Road Run Slope (%)	3.4
N/A	Gutter Run Slope (%)	N/A		Road Cross Slope (%)	0
N/A	Gutter Cross Slope (%)	N/A			
Yes	Overall Surface Condition: Acceptable		Yes	Perp Joint Present	Yes
	Cross Gutter Present?	Yes		Spandrel Present?	Yes
	Replace Cross Gutter?	No		Replace Spandrel?	No

Possible Solutions:
Remove & Replace Curb Ramp With Two New Directional Ramps or Equivalent.

OC Std/PROW:
R304.2.2, R304.5.3, STD 1115
