# Access Compliance Report Public Rights-of-Way (Curb Ramps)

Main Street: HEWES\_AVE Cross Street: N/A Location: NE

ADA ID: RPRK220127142517 Ramp Type: Type 1 - Perpendicular Diagonal Initial Pass/Fail: Fail Overall Compliance: No Severity Score: 15

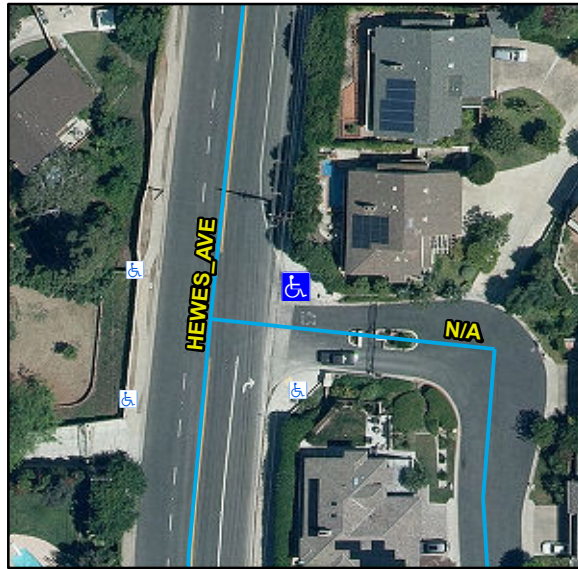
| Compliance | Description | Data | Compliance | Description | Data |
|---|---|---|---|---|---|
| No | Ramp Run Slope (%) | 9.3 | N/A | Flare Slope LT (%) | N/A |

**Remove & Replace Curb Ramp With Two New Directional Ramps or Equivalent.**

**R304.2.2, STD 1115**
