# Access Compliance Report Public Rights-of-Way (Curb Ramps)

Main Street: FOWLER\_AVE Cross Street: CHARMAINE\_LN Location: SE

ADA ID: RPRK220127142923 Ramp Type: Type 4 - Parallel Initial Pass/Fail: Fail Overall Compliance: No Severity Score: 32

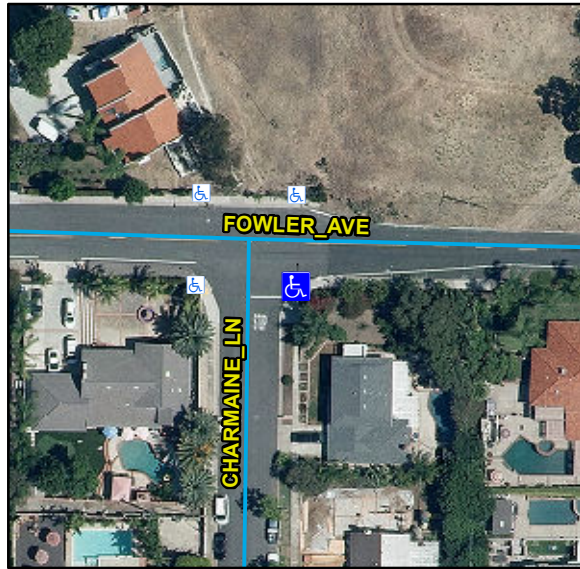
| Compliance | Description | Data | Compliance | Description | Data |
|---|---|---|---|---|---|
| No | Ramp Run Slope LT (%) | 20 | No | Ramp Run Slope RT (%) | 14.4 |
| No | Ramp Cross Slope LT (%) | 2.2 | Yes | Ramp Cross Slope RT (%) | 1.2 |

**Remove & Replace Curb Ramp With Two New Directional Ramps or Equivalent.**

**R304.3.2, R304.5.3, STD 1115**

Total Cost: \$ 4000
