# Access Compliance Report Public Rights-of-Way (Curb Ramps)

| Main Street: VALENCIA_AVE | | Cross Street: BIRCH_ST | | Location: | SW |
| ADA ID: RPRK220201115812 | Ramp Type: Blended Transition 1 | Initial Pass/Fail: Pass | Overall Compliance: No | Severity Score: | 20 |

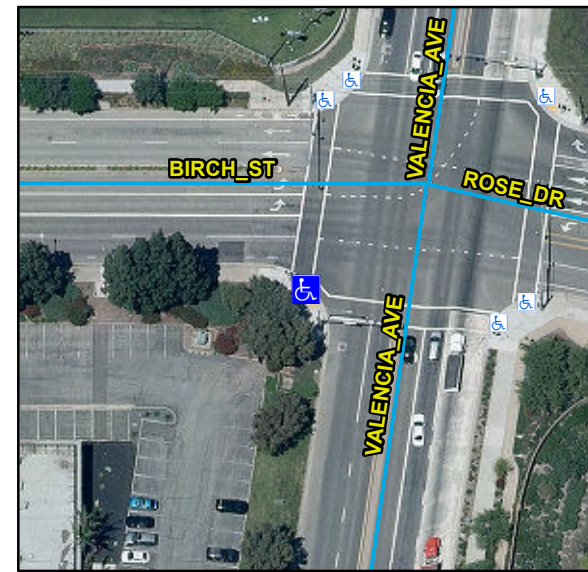
| Compliance | Description | Data | Compliance | Description | Data |
|---|---|---|---|---|---|
| No | Obstructions Present? | Yes | N/A | Utilities Present? | Yes |
| | Obstruction Types | Pushbutton Post | | Utility Types | |

| Compliance | Description | Data | Compliance | Description | Data |
|---|---|---|---|---|---|
| No | Gutter Cross Slope (%) | 4 | | | |

Possible Solutions:

**Remove & Replace Gutter. Relocate Obstruction. Utility Present.**
