# Access Compliance Report Public Rights-of-Way (Curb Ramps)

Main Street: VALENCIA\_AVE Cross Street: ROSE\_DR Location: NE

ADA ID: RPRK220201120659 Ramp Type: Blended Transition 1 Initial Pass/Fail: Fail Overall Compliance: No Severity Score: 30

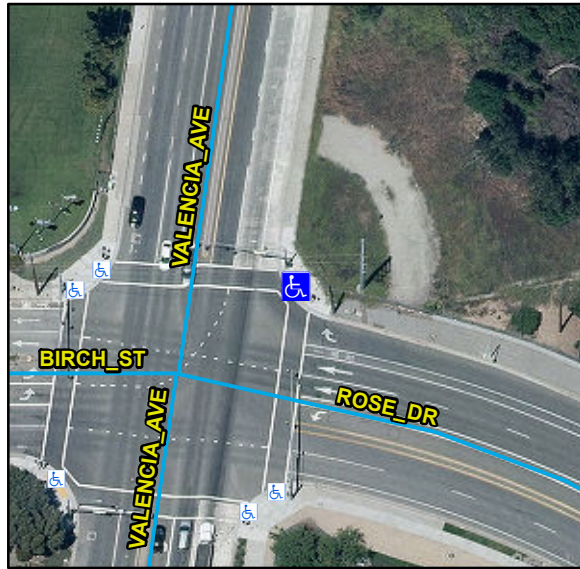
| Compliance | Description | Data | Compliance | Description | Data |
|---|---|---|---|---|---|
| No | Ramp Run Slope (%) | 5.2 | N/A | Flare Slope RT (%) | N/A |
| No | Ramp Cross Slope (%) | 6 | N/A | Flare Traversable RT | N/A |

Remove & Replace Curb Ramp With Two New Directional Ramps or Equivalent.

R304.2.2, R304.5.3, STD 1115
