# Access Compliance Report Public Rights-of-Way (Curb Ramps)

Main Street: N/A Cross Street: LAMBERT\_RD Location: N

ADA ID: RPRK220201122941 Ramp Type: Type 6 - Directional 1 Initial Pass/Fail: Pass Overall Compliance: No Severity Score: 10

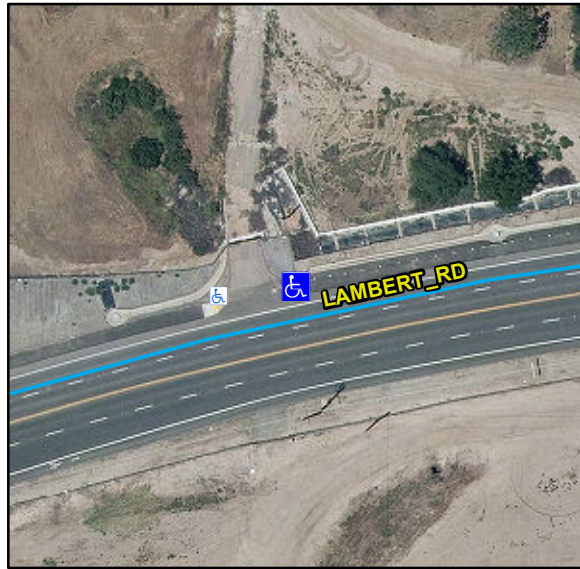
| Compliance | Description | Data | Compliance | Description | Data |
|---|---|---|---|---|---|
| N/A | Landing Present | No | Yes | DWS Contrast | Yes |
| No | Landing Length (in) | N/A | Yes | DWS Length (in) | 80 |
| No | Landing Width (in) | N/A | Yes | DWS Full Width | Yes |
| No | Landing Run Slope (%) | N/A | | DWS Offset Type | Single |
| No | Landing Cross Slope (%) | N/A | Yes | DWS Left Offset (in) | 0 |
| No | Gutter Ponding | Yes | Yes | Curb Slope | 5.2 |
| No | Gutter Cross Slope (%) | 2.2 | | Parallel Ramp Side | Left |

Install Landing. Remove & Replace Gutter.

R304.2.1, R304.2.2-Perp, R304.3.2-Para, R304.5.3, R302.7, STD 1115
