# Access Compliance Report Public Rights-of-Way (Curb Ramps)

| Main Street: N/A | | Cross Street: LAMBERT_RD | | Location: N | |
| ADA ID: RPRK220201123241 | Ramp Type: Type 6 - Directional 1 | Initial Pass/Fail: Pass | Overall Compliance: No | Severity Score: 10 | |

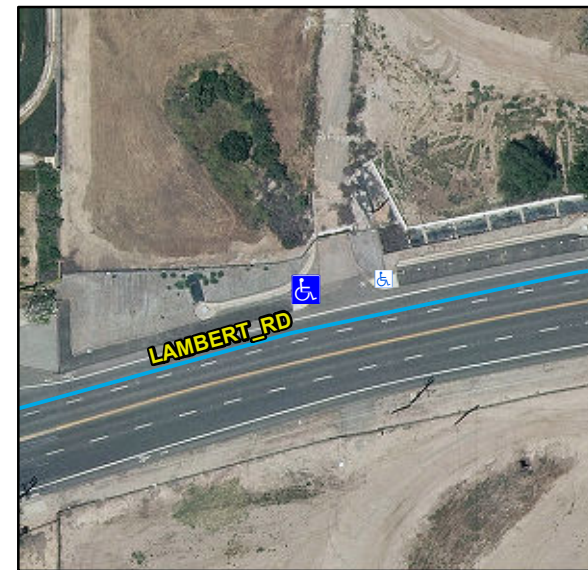
| Compliance | Description | Data | Compliance | Description | Data |
|---|---|---|---|---|---|
| N/A | Landing Present | No | Yes | DWS Contrast | Yes |
| No | Landing Length (in) | N/A | Yes | DWS Length (in) | 80 |
| No | Landing Width (in) | N/A | Yes | DWS Full Width | Yes |
| No | Landing Run Slope (%) | N/A | | DWS Offset Type | Single |
| No | Landing Cross Slope (%) | N/A | Yes | DWS Left Offset (in) | 0 |
| No | Gutter Ponding | Yes | Yes | Curb Slope | 3.7 |
| No | Gutter Cross Slope (%) | 2.2 | | Parallel Ramp Side | Right |

Install Landing. Remove & Replace Gutter.

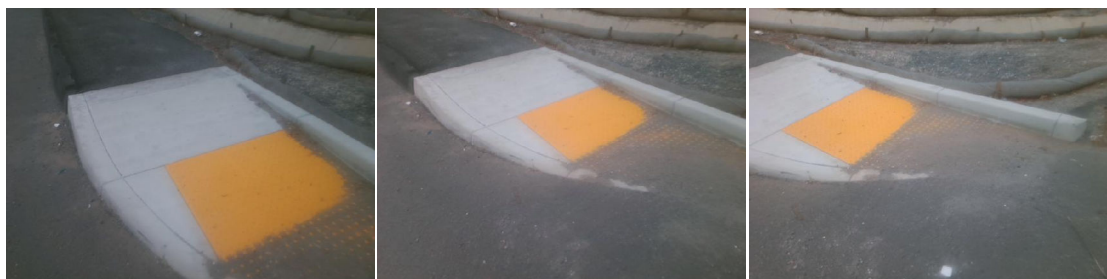
| Compliance | Description | Data | Compliance | Description | Data |
| N/A | Ramp Length (in) | 140 | N/A | Flare Type LT | |
| Yes | Ramp Width (in) | 65 | | | Sloped |
| Yes | Ramp Run Slope (%) | 6.6 | Yes | Flare Slope LT (%) | 5.9 |
| Yes | Ramp Cross Slope (%) | 0.5 | N/A | Flare Traversable LT | Yes |

#### Possible Solutions:
