# Access Compliance Report Public Rights-of-Way (Curb Ramps)

Main Street: PALM\_DR Cross Street: ROXBOROUGH\_DR Location: N

ADA ID: RPRK220201130315 Ramp Type: Type 4 - Parallel Initial Pass/Fail: Fail Overall Compliance: No Severity Score: 15

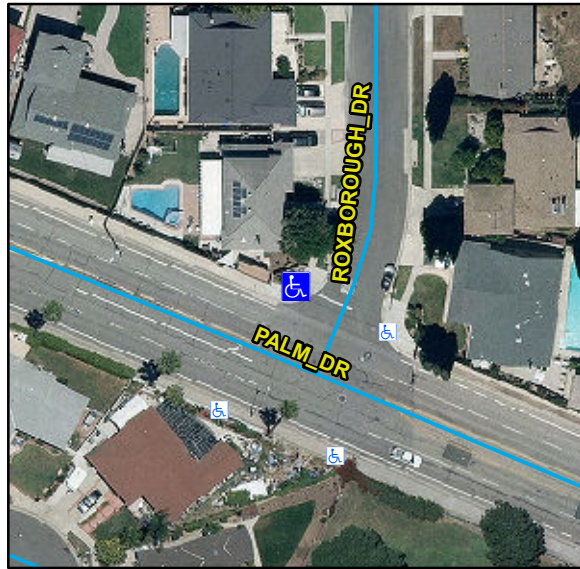
| Compliance | Description | Data | Compliance | Description | Data |
|---|---|---|---|---|---|
| No | Ramp Cross Slope LT (%) | 5.4 | No | Ramp Cross Slope RT (%) | 3.2 |

Remove & Replace Curb Ramp With Two New Directional Ramps or Equivalent.

R304.5.3, STD 1115

Total Cost: \$ 4000
