# Access Compliance Report Public Rights-of-Way (Curb Ramps)

Main Street: E\_YORBA\_LINDA\_BLV D Cross Street: MCCORMACK\_LN Location: NW

ADA ID: RPRK220201133014 Ramp Type: Type 1 - Perpendicular Diagonal Initial Pass/Fail: Pass Overall Compliance: No Severity Score: 0

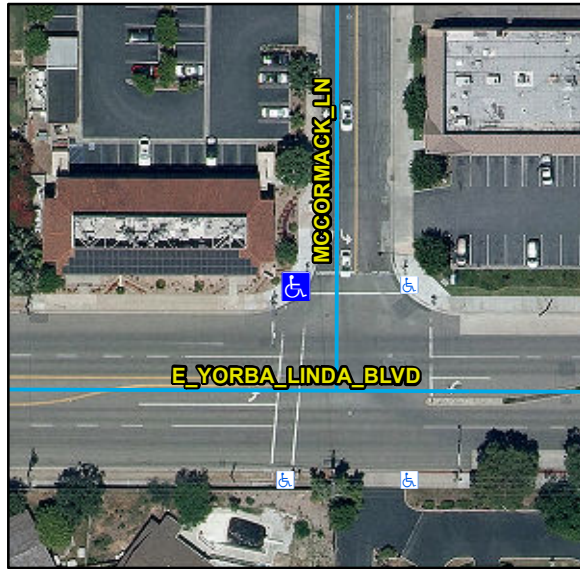
| Compliance | Description | Data | Compliance | Description | Data |
|---|---|---|---|---|---|
| N/A | Landing Present | Yes | N/A | Flare Type RT | |
| N/A | Landing Length (in) | 51 | | | Sloped |
| N/A | Landing Movement Obstructed? | Yes | Yes | DWS Contrast | Yes |
| | Landing Movement Type | Curb | Yes | DWS Length (in) | 36 |

Possible Solutions:

Remove & Replace Landing.

R304.2.1, STD 1115

Total Cost: \$ 531
