# Access Compliance Report Public Rights-of-Way (Curb Ramps)

Main Street: E\_YORBA\_LINDA\_BLVD Cross Street: MCCORMACK\_LN Location: S

ADA ID: RPRK220201133632 Ramp Type: Type 3 - Combination 1 Initial Pass/Fail: Pass Overall Compliance: No Severity Score: 2

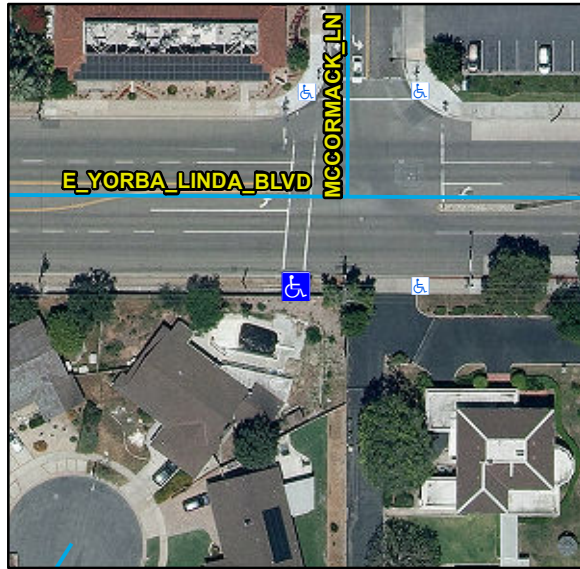
Gutter Ponding Observed.

| Compliance | Description | Data | Compliance | Description | Data |
|---|---|---|---|---|---|
| No | Gutter Ponding | Yes | Yes | Curb Slope | 4.1 |

R302.7, STD 1115

Total Cost: \$ 252
