# Access Compliance Report Public Rights-of-Way (Curb Ramps)

Main Street: MCFADDEN\_AVE Cross Street: WILSON\_ST Location: SE

ADA ID: RPRK220202113750 Ramp Type: Type 4 - Parallel Initial Pass/Fail: Pass Overall Compliance: No Severity Score: 5

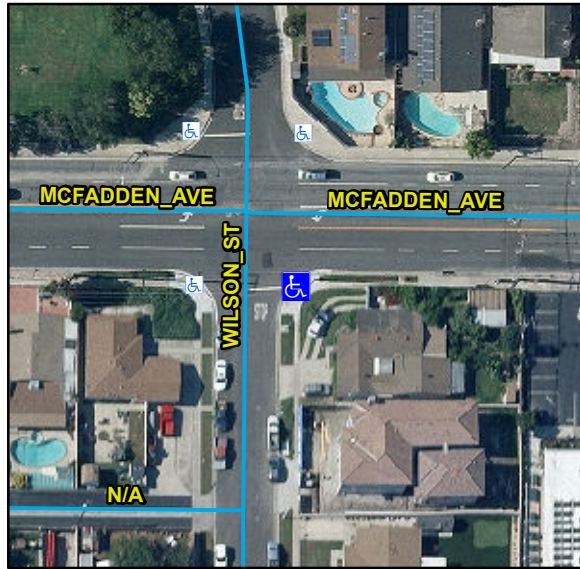
| Compliance | Description | Data | Compliance | Description | Data |
|---|---|---|---|---|---|
| N/A | Landing Movement Obstructed? | No | No | DWS Offset Left (in) | 6 |
| No | Gutter Run Slope (%) | 5.2 | | Road Cross Slope (%) | 0.9 |

Remove & Replace Detectable Warning System.  
Remove & Replace Gutter.
