# Access Compliance Report Public Rights-of-Way (Curb Ramps)

Main Street: N/A Cross Street: MCFADDEN\_AVE Location: N

ADA ID: RPRK220202114611 Ramp Type: Type 6 - Directional 1 Initial Pass/Fail: Pass Overall Compliance: No Severity Score: 0

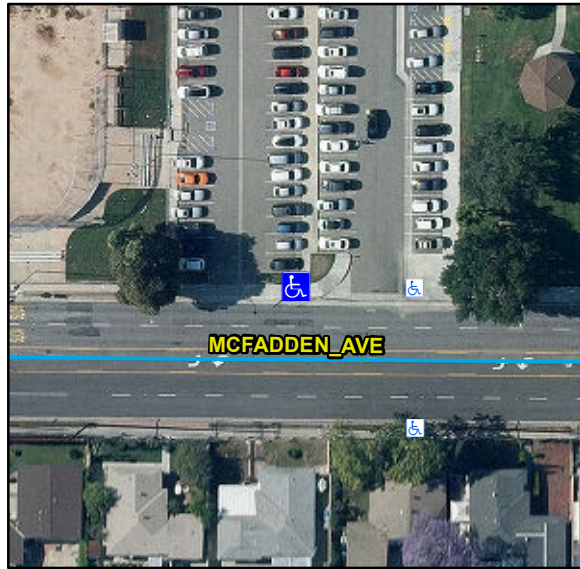
| Compliance | Description | Data | Compliance | Description | Data |
|---|---|---|---|---|---|
| No | Landing Run Slope (%) | 2.7 | | DWS Offset Type | Single |

Possible Solutions:

Remove & Replace Entire Ramp.

R304.2.2-Perp, R304.3.2-Para, R304.2.3, STD 1115
