# Access Compliance Report Public Rights-of-Way (Curb Ramps)

| Main Street: VAN_BUREN_ST | | Cross Street: MCFADDEN_AVE | | Location: | SW |
| ADA ID: RPRK220202115610 | Ramp Type: Type 4 - Parallel | Initial Pass/Fail: Pass | Overall Compliance: No | Severity Score: | 0 |

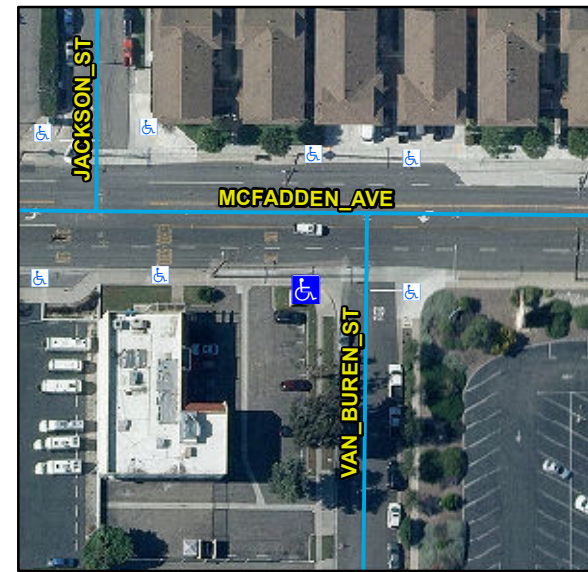
| Compliance | Description | Data | Compliance | Description | Data |
|---|---|---|---|---|---|
| No | Landing Run Slope (%) | 4 | Yes | DWS Full Width | Yes |
| N/A | Landing Movement Obstructed? | No | No | DWS Offset Left (in) | 3 |

**Remove & Replace Curb Ramp With Two New Directional Ramps or Equivalent.**

**R304.2.2-Perp, R304.3.2-Para, R305.2, STD 1115**

Total Cost: \$ 4000

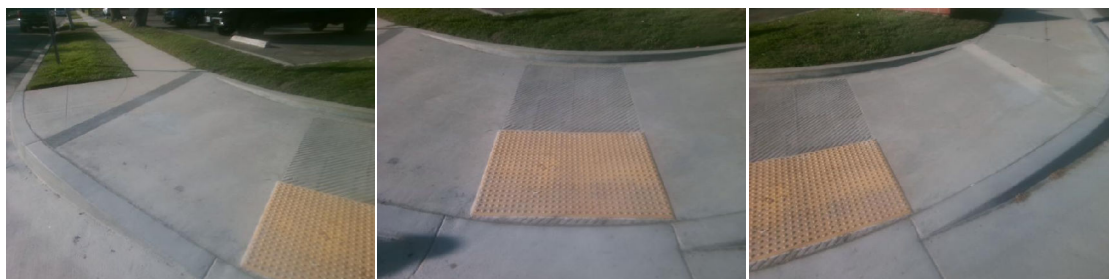
## Obstruction and Utility Measurement/Component Compliance

| Compliance | Description | Data | Compliance | Description | Data |
|---|---|---|---|---|---|
| Yes | Obstructions Present? | No | N/A | Utilities Present? | No |
