# Access Compliance Report Public Rights-of-Way (Curb Ramps)

Main Street: MCFADDEN\_AVE Cross Street: VAN\_BUREN\_ST Location: SE

ADA ID: RPRK220202115942 Ramp Type: Type 4 - Parallel Initial Pass/Fail: Fail Overall Compliance: No Severity Score: 16

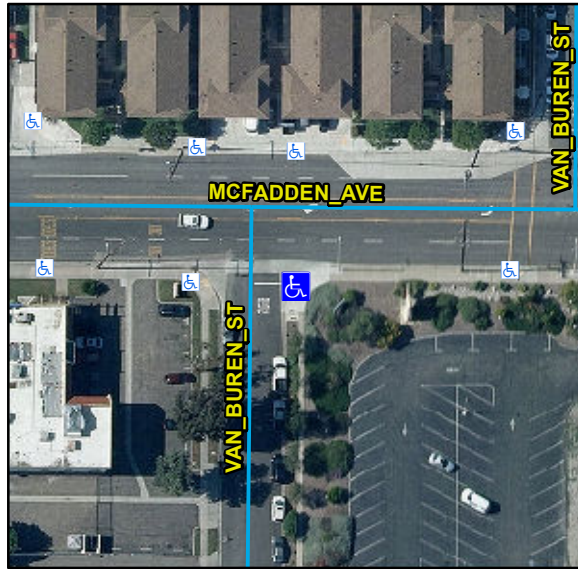
| Compliance | Description | Data | Compliance | Description | Data |
|---|---|---|---|---|---|
| Yes | Ramp Run Slope LT (%) | 8.1 | No | Ramp Run Slope RT (%) | 8.4 |
| No | Ramp Cross Slope LT (%) | 2.1 | Yes | Ramp Cross Slope RT (%) | 2 |

Remove & Replace Curb Ramp With Two New Directional Ramps or Equivalent.

R304.5.3, R304.3.2, STD 1115
