# Access Compliance Report Public Rights-of-Way (Curb Ramps)

Main Street: MONROE\_ST Cross Street: MCFADDEN\_AVE Location: SW

ADA ID: RPRK220202120429 Ramp Type: Type 4 - Parallel Initial Pass/Fail: Pass Overall Compliance: No Severity Score: 5

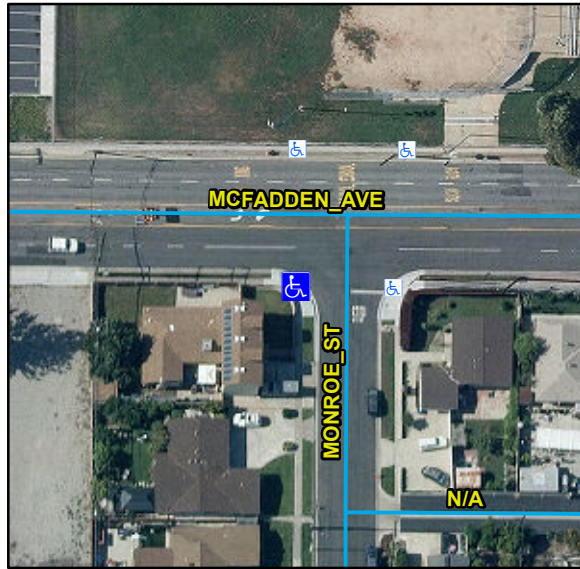
| Compliance | Description | Data | Compliance | Description | Data |
|---|---|---|---|---|---|
| No | Gutter Run Slope (%) | 7.4 | | Road Cross Slope (%) | 4.1 |

Remove & Replace Gutter.

R304.5.4, STD 1115

Total Cost: \$ 252
