# Access Compliance Report Public Rights-of-Way (Curb Ramps)

Main Street: HAZARD\_RD Cross Street: BEACH\_BLVD Location: N

ADA ID: RPRK220202124237 Ramp Type: Type 4 - Parallel Initial Pass/Fail: Fail Overall Compliance: No Severity Score: 16

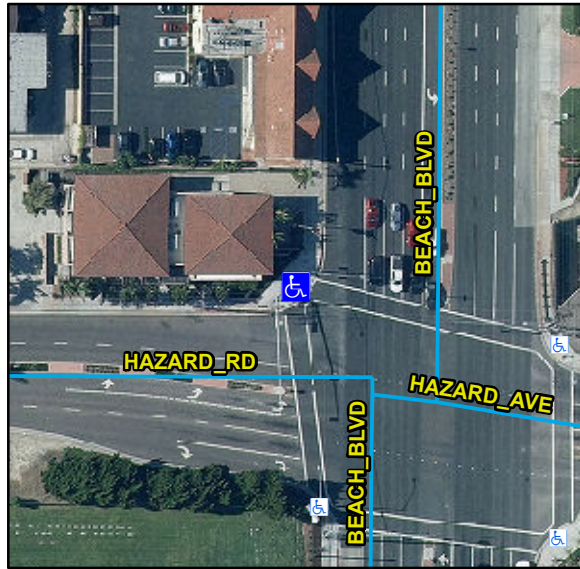
| Compliance | Description | Data | Compliance | Description | Data |
|---|---|---|---|---|---|
| Yes | Ramp Run Slope LT (%) | 4.8 | No | Ramp Run Slope RT (%) | 8.6 |

Remove & Replace Curb Ramp With Two New Directional Ramps or Equivalent.

R304.3.2, STD 1115

\$ 4000
