# Access Compliance Report Public Rights-of-Way (Curb Ramps)

Main Street: BEACH\_BLVD Cross Street: HAZARD\_AVE Location: NE

ADA ID: RPRK220202124844 Ramp Type: Type 1 - Perpendicular Diagonal Initial Pass/Fail: Fail Overall Compliance: No Severity Score: 15

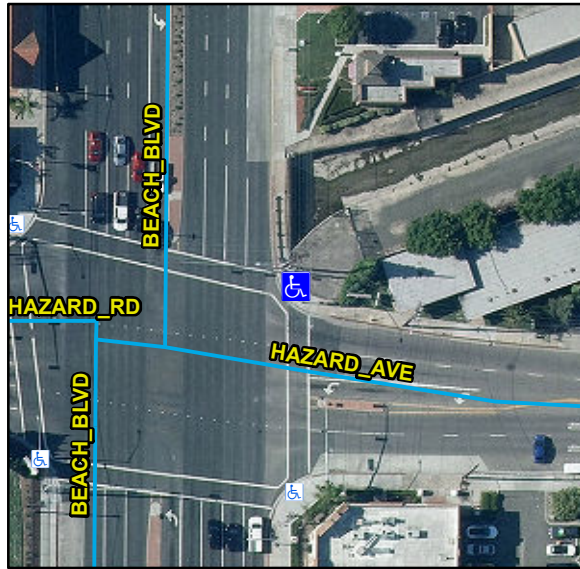
| Compliance | Description | Data | Compliance | Description | Data |
|---|---|---|---|---|---|
| No | Ramp Run Slope (%) | 8.6 | N/A | Flare Slope LT (%) | N/A |

Remove & Replace Curb Ramp With Two New Directional Ramps or Equivalent.

R304.2.2, STD 1115
