# Access Compliance Report

## Public Rights-of-Way

### (Curb Ramps)

Main Street: **HAZARD\_AVE** Cross Street: **JEFFERSON\_ST** Location: **SE**

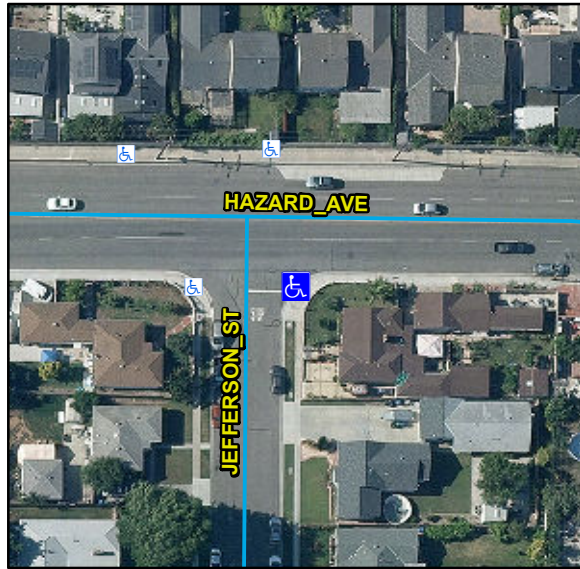
ADA ID: **RPRK220202132151** Ramp Type: **Type 4 - Parallel** Initial Pass/Fail: **Pass** Overall Compliance: **Yes** Severity Score: **0**

#### Field Measurements/Component Compliance

Possible Solutions:

**N/A**
