# Access Compliance Report Public Rights-of-Way (Curb Ramps)

Main Street: VAN\_BUREN\_ST Cross Street: ELMORE\_WAY Location: SW

ADA ID: RPRK220202151439 Ramp Type: Type 4 - Parallel Initial Pass/Fail: Pass Overall Compliance: No Severity Score: 4

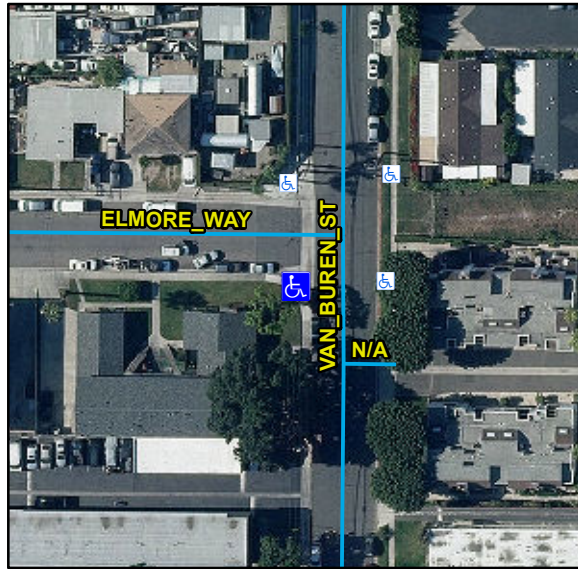
**Remove & Replace Landing. Gutter Ponding Observed.**

| Compliance | Description | Data | Compliance | Description | Data |
|---|---|---|---|---|---|
| No | Landing Width (in) | 45 | Yes | DWS Length (in) | 36 |
| No | Gutter Ponding | Yes | Yes | Curb Slope | 3.8 |

Possible Solutions:

**R304.2.1, R302.7, STD 1115**
