# Access Compliance Report Public Rights-of-Way (Curb Ramps)

Main Street: VAN\_BUREN\_ST Cross Street: BOLSA\_AVE Location: SW

ADA ID: RPRK220202152641 Ramp Type: Type 4 - Parallel Initial Pass/Fail: Fail Overall Compliance: No Severity Score: 2

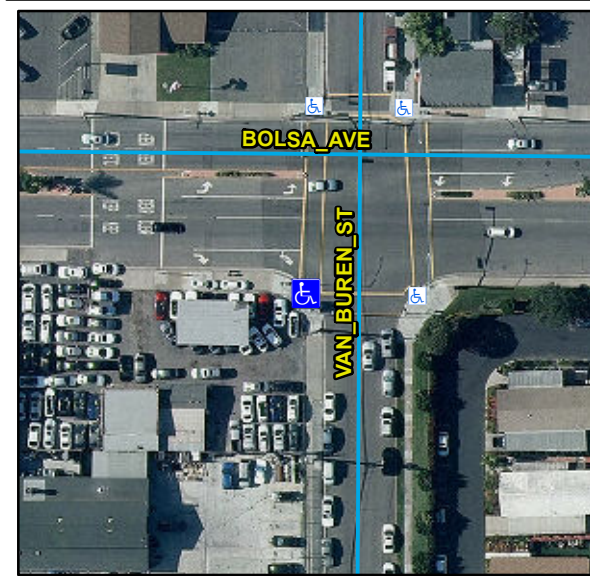
| Compliance | Description | Data | Compliance | Description | Data |
|---|---|---|---|---|---|
| No | Ramp Cross Slope LT (%) | 2.5 | Yes | Ramp Cross Slope RT (%) | 1.7 |

Remove & Replace Curb Ramp With Two New Directional Ramps or Equivalent.

R304.5.3, STD 1115

Total Cost: \$ 4000
