# Access Compliance Report Public Rights-of-Way (Curb Ramps)

Main Street: HAZARD\_AVE Cross Street: HARPER\_ST Location: SE

ADA ID: RPRK220203112134 Ramp Type: Type 4 - Parallel Initial Pass/Fail: Fail Overall Compliance: No Severity Score: 2

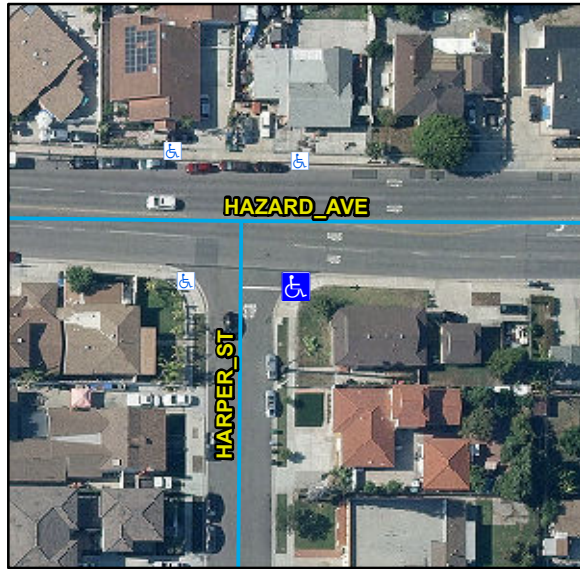
| Compliance | Description | Data | Compliance | Description | Data |
|---|---|---|---|---|---|
| No | Ramp Cross Slope LT (%) | 3.4 | Yes | Ramp Cross Slope RT (%) | 0.3 |

Remove & Replace Curb Ramp With Two New Directional Ramps or Equivalent.

R304.5.3, STD 1115

Total Cost: \$ 4000
