# Access Compliance Report Public Rights-of-Way (Curb Ramps)

Main Street: RIATA\_ST Cross Street: HAZARD\_AVE Location: SW

ADA ID: RPRK220203120154 Ramp Type: Type 4 - Parallel Initial Pass/Fail: Fail Overall Compliance: No Severity Score: 2

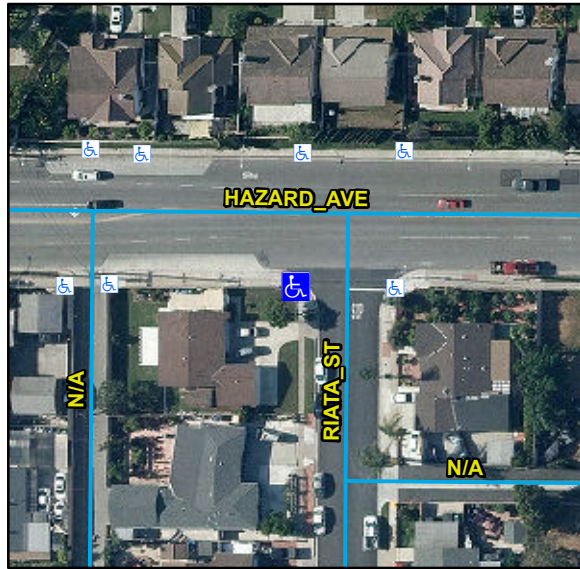
| Compliance | Description | Data | Compliance | Description | Data |
|---|---|---|---|---|---|
| Yes | Ramp Cross Slope LT (%) | 1.4 | No | Ramp Cross Slope RT (%) | 2.4 |

**Remove & Replace Curb Ramp With Two New Directional Ramps or Equivalent.**

**R304.5.3, STD 1115**
