# Access Compliance Report Public Rights-of-Way (Curb Ramps)

| Main Street: HAZARD_AVE | | Cross Street: RIATA_ST | | Location: | SE |

| ADA ID: RPRK220203120452 | Ramp Type: Type 4 - Parallel | Initial Pass/Fail: Fail | Overall Compliance: No | Severity Score: | 15 |

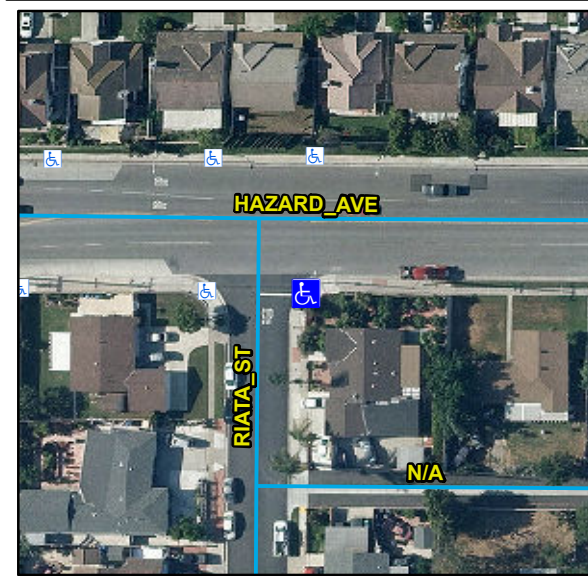
| Compliance | Description | Data | Compliance | Description | Data |
|---|---|---|---|---|---|
| No | Ramp Run Slope LT (%) | 8.4 | Yes | Ramp Run Slope RT (%) | 5.3 |

**Remove & Replace Curb Ramp With Two New Directional Ramps or Equivalent.**

**R304.3.2, STD 1115**

Total Cost: \$ 4000
