# Access Compliance Report Public Rights-of-Way (Curb Ramps)

**Main Street: PURDY\_ST** **Cross Street: HAZARD\_AVE** **Location: NE**

**ADA ID: RPRK220203121510** **Ramp Type: Type 4 - Parallel** **Initial Pass/Fail: Fail** **Overall Compliance: No** **Severity Score: 2**

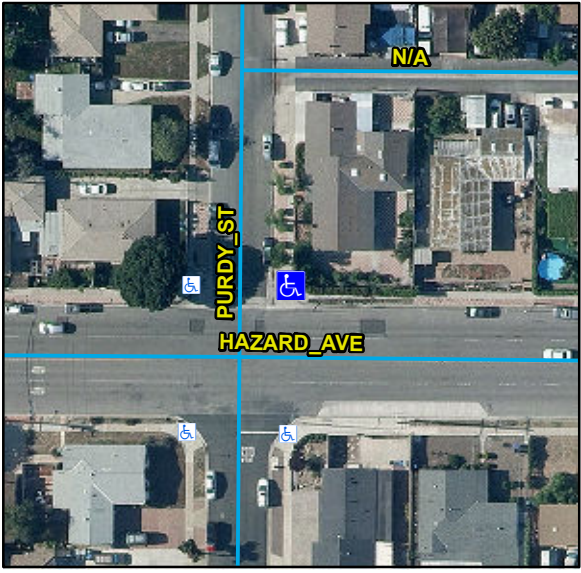
Compliance	Description	Data	Compliance	Description	Data
N/A	Ramp Length LT (in)	111	N/A	Ramp Length RT (in)	124
Yes	Ramp Width LT (in)	102	Yes	Ramp Width RT (in)	102
Yes	Ramp Run Slope LT (%)	4.4	Yes	Ramp Run Slope RT (%)	7
No	Ramp Cross Slope LT (%)	2.8	No	Ramp Cross Slope RT (%)	3.5
N/A	Landing Present	N/A	N/A	DWS Provided	N/A
N/A	Landing Length (in)	N/A	N/A	DWS Contrast	N/A
N/A	Landing Width (in)	N/A	N/A	DWS Length (in)	N/A
N/A	Landing Run Slope (%)	N/A	N/A	DWS Full Width	N/A
N/A	Landing Cross Slope (%)	N/A		DWS Offset Type	N/A
N/A	Landing Movement Obstructed?	N/A	N/A	DWS Offset Left (in)	N/A
	Landing Movement Type	N/A	N/A	DWS Offset Right (in)	N/A
N/A	Landing Shared	N/A			
N/A	Clear Space	Yes			
N/A	Clear Space To Crosswalk (in)	N/A			
N/A	Marked Crosswalk 1	No	N/A	Marked Crosswalk 2	No
	Crossing 1 Direction	W		Crossing 2 Direction	S
N/A	Marked Crosswalk 1 Width (in)	N/A		Marked Crosswalk 2 Width (in)	N/A

Possible Solutions:  
**Remove & Replace Curb Ramp With Two New Directional Ramps or Equivalent.**

OC Std/PROW:  
**R204.3, R304.5.3, STD 1115**

Total Cost: **\$ 4000**

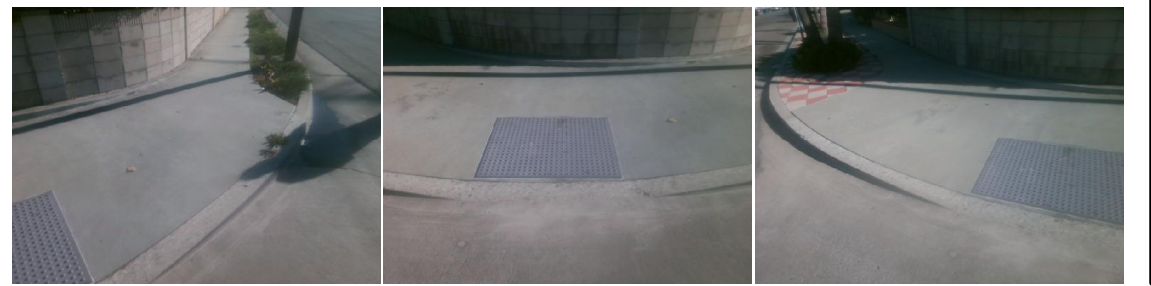
N/A	Ramp Inside Crosswalk 1	N/A	N/A	Ramp Inside Crosswalk 2	N/A
	Crossing 1 Slope (%)	0.9		Crossing 2 Slope (%)	2.5
	Crossing 1 Cross Slope (%)	2.3		Crossing 2 Cross Slope (%)	0.9
N/A	Gutter Ponding	N/A	N/A	Curb Slope	1.4
Yes	Gutter Lip Height (in)	0		Road Run Slope (%)	0.4
N/A	Gutter Run Slope (%)	N/A		Road Cross Slope (%)	0
N/A	Gutter Cross Slope (%)	N/A	No	Perpendicular Joint Present	No
Yes	Overall Surface Condition	Acceptable		Spandrel Present?	Yes
	Cross Gutter Present?	Yes		Replace Spandrel?	No
	Replace Cross Gutter?	No
