# Access Compliance Report Public Rights-of-Way (Curb Ramps)

Main Street: HAZARD\_AVE Cross Street: PURDY\_ST Location: NW

ADA ID: RPRK220203121840 Ramp Type: Type 4 - Parallel Initial Pass/Fail: Fail Overall Compliance: No Severity Score: 2

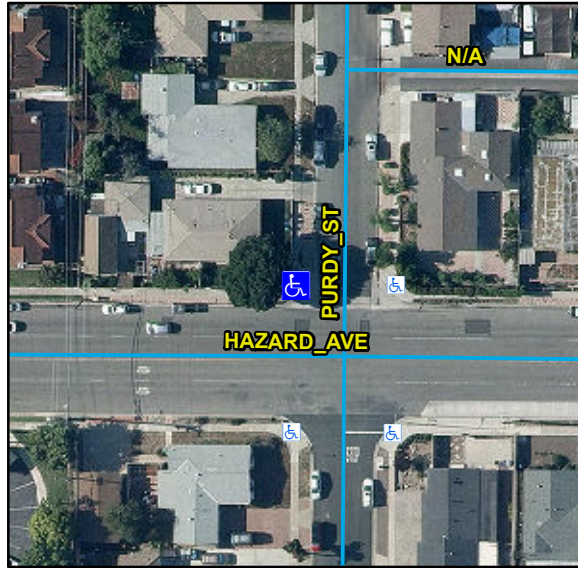
| Compliance | Description | Data | Compliance | Description | Data |
|---|---|---|---|---|---|
| No | Ramp Cross Slope LT (%) | 3.5 | No | Ramp Cross Slope RT (%) | 2.7 |

**Remove & Replace Curb Ramp With Two New Directional Ramps or Equivalent.**

**R204.3, R304.5.3, STD 1115**
