# Access Compliance Report Public Rights-of-Way (Curb Ramps)

Main Street: N/A Cross Street: HAZARD\_AVE Location: NE

ADA ID: RPRK220203122207 Ramp Type: Type 4 - Parallel Initial Pass/Fail: Fail Overall Compliance: No Severity Score: 15

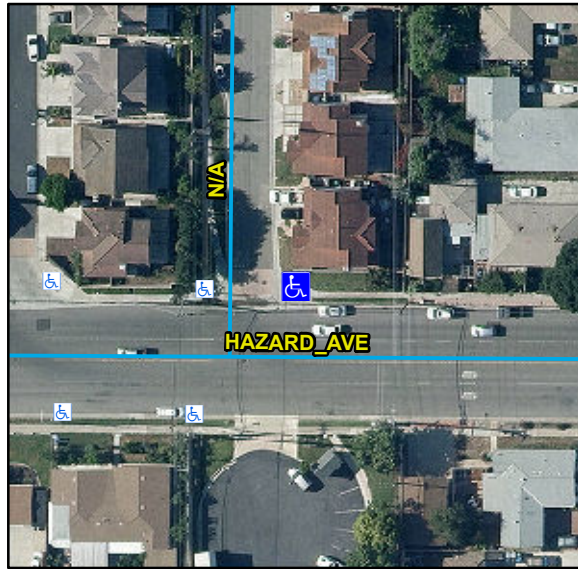
| Compliance | Description | Data | Compliance | Description | Data |
|---|---|---|---|---|---|
| No | Ramp Run Slope LT (%) | 9 | Yes | Ramp Run Slope RT (%) | 6 |

**Remove & Replace Curb Ramp With Two New Directional Ramps or Equivalent.**

**R304.3.2, STD 1115**
