# Access Compliance Report Public Rights-of-Way (Curb Ramps)

Main Street: HAZARD\_AVE Cross Street: N/A Location: NW

ADA ID: RPRK220203122513 Ramp Type: Type 4 - Parallel Initial Pass/Fail: Fail Overall Compliance: No Severity Score: 15

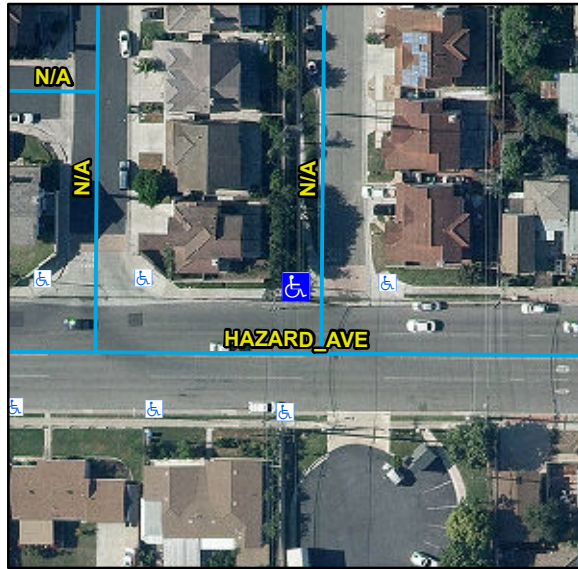
| Compliance | Description | Data | Compliance | Description | Data |
|---|---|---|---|---|---|
| Yes | Ramp Run Slope LT (%) | 3.2 | No | Ramp Run Slope RT (%) | 8.4 |

**Remove & Replace Curb Ramp With Two New Directional Ramps or Equivalent.**

**R304.3.2, STD 1115**
