# Access Compliance Report Public Rights-of-Way (Curb Ramps)

Main Street: RIATA\_ST Cross Street: PYLE\_WAY Location: NE

ADA ID: RPRK220203122948 Ramp Type: Type 4 - Parallel Initial Pass/Fail: Fail Overall Compliance: No Severity Score: 2

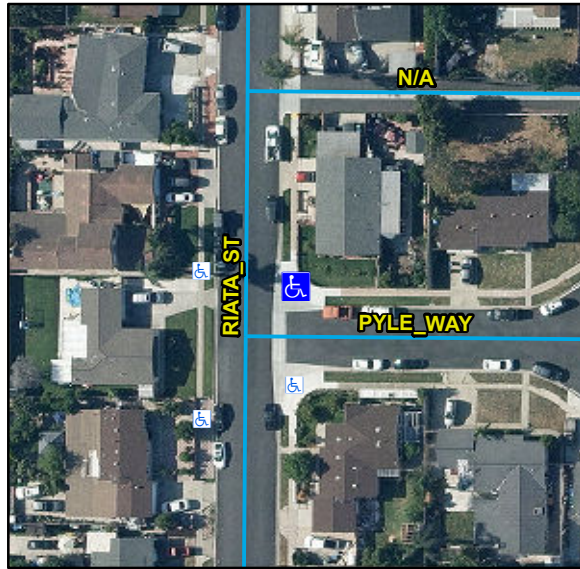
| Compliance | Description | Data | Compliance | Description | Data |
|---|---|---|---|---|---|
| No | Ramp Cross Slope LT (%) | 2.8 | Yes | Ramp Cross Slope RT (%) | 1.3 |

**Remove & Replace Curb Ramp With Two New Directional Ramps or Equivalent.**

**R304.5.3, STD 1115**
